# 41 PRESERVATION BRIEFS

## The Seismic Retrofit of Historic Buildings: Keeping Preservation in the Forefront

David W. Look, AIA, Terry Wong, PE,  
and Sylvia Rose Augustus

U.S. Department of the Interior  
National Park Service  
Cultural Resources  
Heritage Preservation Services

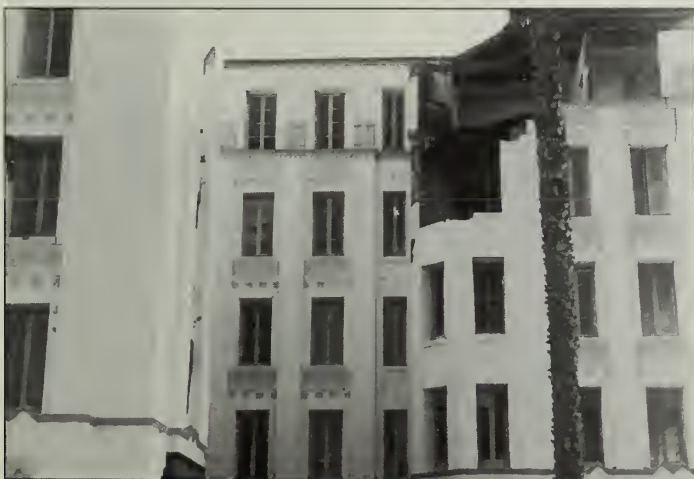
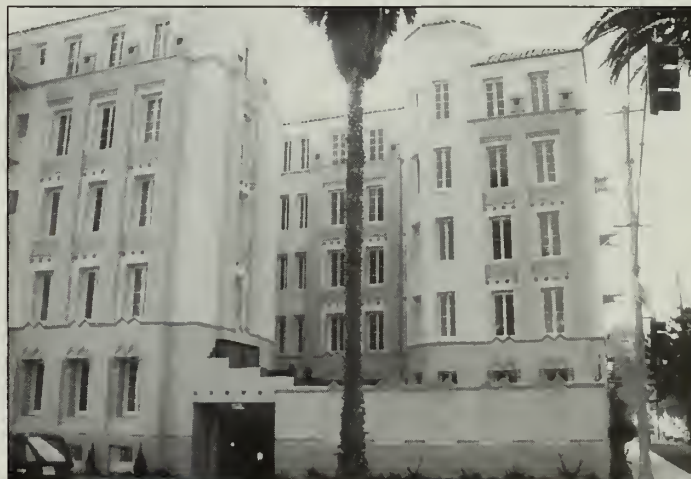
1. Earthquake damage to historic buildings can be repaired in a manner sensitive to their historic character as seen in this ca. 1928 five story apartment building. The owners used a combination of federal rehabilitation tax credits, community development block grants, and post earthquake grants to fund a portion of the rehabilitation and seismic upgrade costs. Photos: Historic Resources Group, Los Angeles.

Although historic and other older buildings can be retrofitted to survive earthquakes, many retrofit practices damage or destroy the very features that make such buildings significant. Life-safety issues are foremost and, fortunately, there are various approaches which can save historic buildings both from the devastation caused by earthquakes and from the damage inflicted by well-intentioned but insensitive retrofit procedures. Building owners, managers, consultants, and communities need to be actively involved in preparing documents and readying irreplaceable historic resources from these damages (see illus.1).

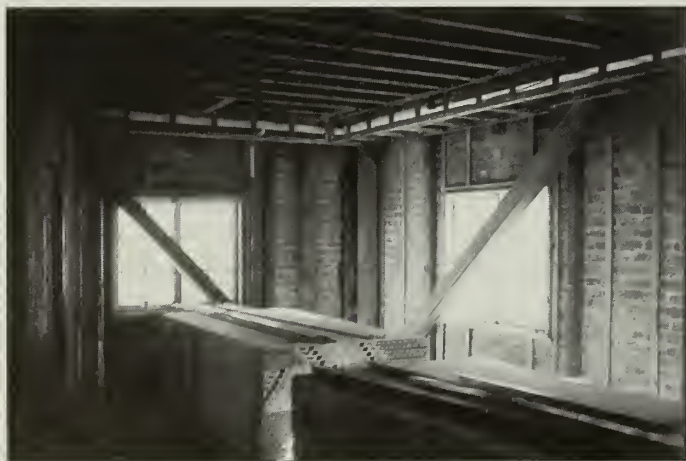
2. Standard approaches to seismic retrofit, as seen with the diagonally braced frame crossing in front of the historic windows, are visually intrusive. Solutions, such as using hidden moment frames around the perimeter of the window, will meet the goals of historic preservation and seismic retrofit. Photo: Steade Craig.

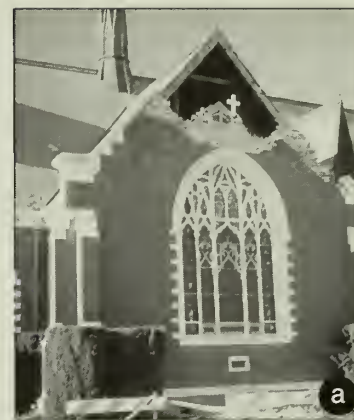
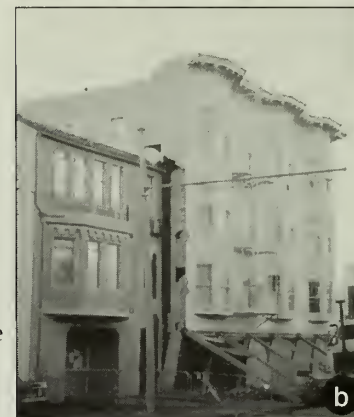
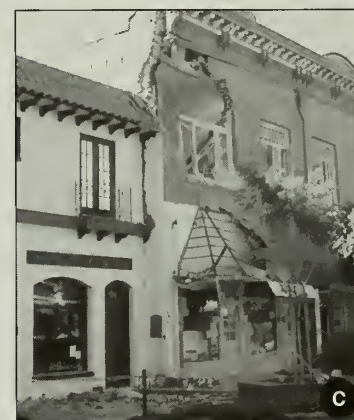
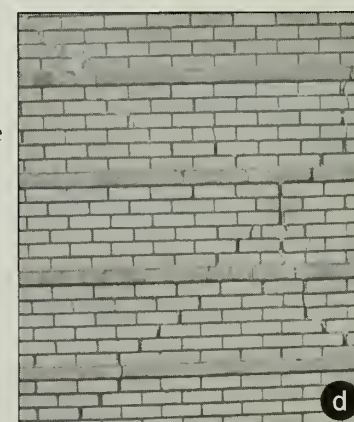
3. Forces from moderate to serious earthquakes caused a) the untied gable to fail, b) the first floor to collapse c) cracks from the pounding effect of adjacent buildings, and d) diagonal cracks in exterior masonry between windows to form. Photos: David Look.

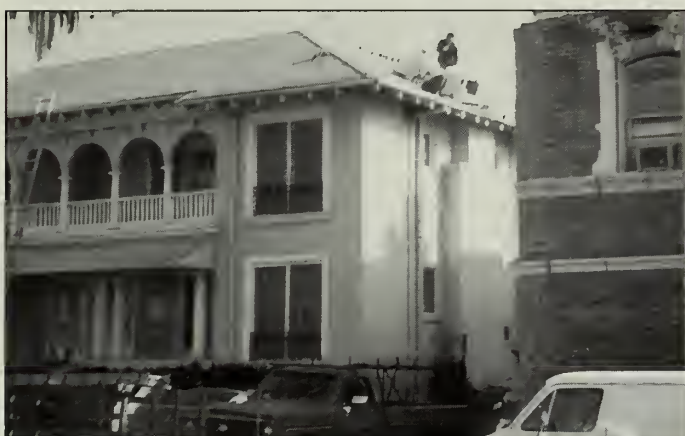
4. The compact size and good condition of the masonry building on the left withstood the earthquake except for the loss of the unsupported chimney at the roof line. The brick building on the right appears to have sustained more damage. Photo: Steade Craig.

The first three factors—the depth, duration, and proximity to the fault—are beyond human control. Recent earthquakes have shown the fourth factor, geological soil conditions, to be as important as any of the other factors because loose, soft soils tend to amplify ground motion, thereby increasing damage. Further, there is the tendency of soft, unstable soils to “liquefy” as the ground vibrates, causing the building foundations to sink unevenly. This fourth factor, geological and soil conditions, is difficult to address in a retrofit situation, although it can be planned for in new construction. The last two factors—the building’s construction type and its existing physical condition—are the two factors over which building owners and managers have control and can ultimately affect how the historic property performs in an earthquake (see illus. 4).

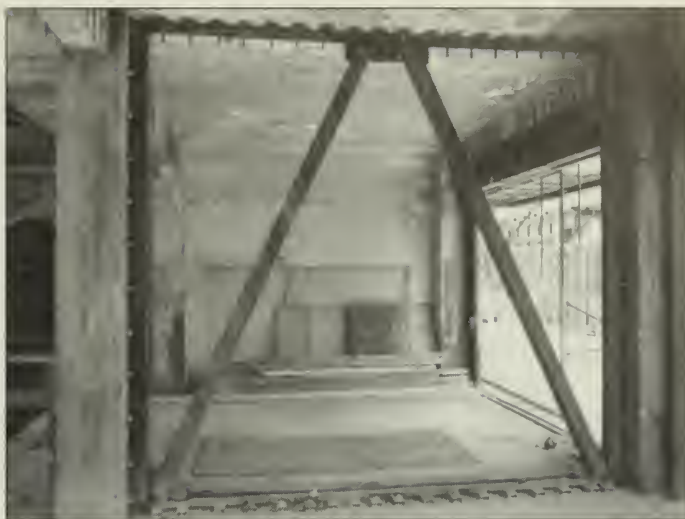
7. More extensive seismic issues can be addressed through structural reinforcement, the most common methods using anchor ties and braces. Shown here is an interior diagonal frame, to be covered, which will dampen and transfer seismic loads in a designed path from foundation to roof. Photo: David Look.

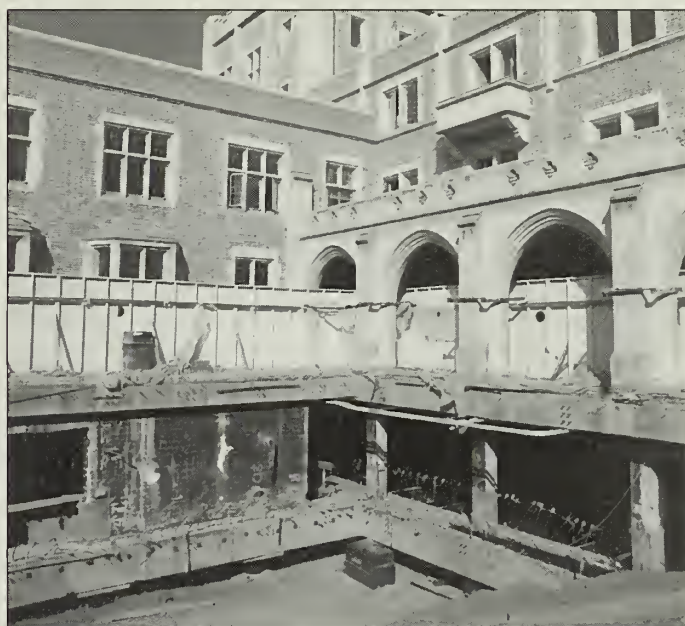
8. Full seismic restructuring to ensure that buildings survive a major earthquake with a minimum of damage may involve extensive reinforcement. Upon completion, the changes to this ca. 1932 Gothic Revival building to add base isolation at the foundation were not visually apparent. Photo: © Jonathan Farrer, courtesy University of California at Los Angeles (UCLA), Capital Programs.

3) *Enhanced Damage Control*. Historic buildings are substantially rehabilitated to meet, to the extent possible, the prescribed building code provision (See illus. 8). Some minor repairable damage would be expected after a major earthquake.

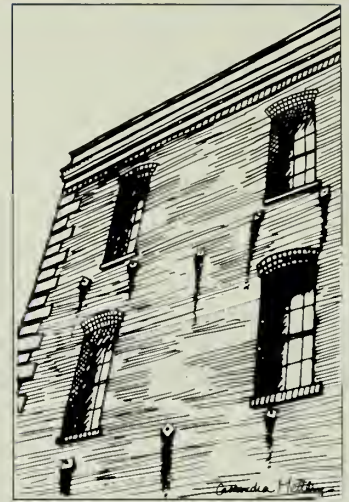
**Not Recommended**

- The anchor bolts on this building were placed in a haphazard fashion. More care should be taken to align the anchor bolt washers. Also, painting the washers can reduce the unsightly rust streaks that result from weathering.
- Do not place anchor bolts at locations with high relief ornamentation.

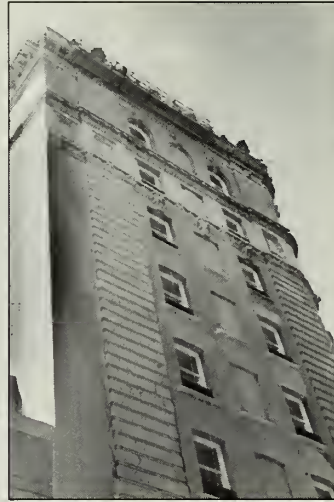
**Recommended**

- Infill of windows should be avoided in all cases. Where absolutely required, however, the appearance of a window opening should be retained to suggest the original visual rhythm of the facade.

The purpose of filling the openings is to increase the shear capacity and reduce the stresses on the unreinforced masonry wall. It is not adequate to just infill with the same unreinforced masonry, but generally a reinforced concrete, reinforced block or reinforced brick is specified. If infilling the openings appears to be the only realistic method, the design solution should be sensitive, and if possible, limited to secondary elevations. The opening should be set back and the facing material should be compatible with the surrounding material.

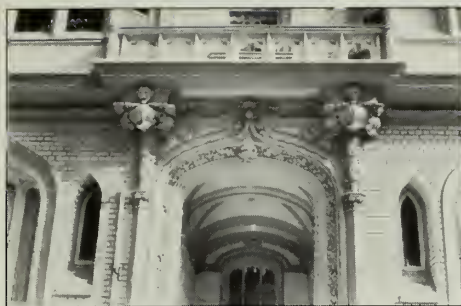
## Recommended

- All original building ornamentation enhances the architectural value and should be retained and maintained.

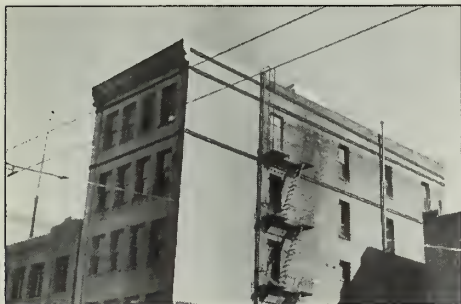
## Recommended

- Exterior bracing or buttressing should incorporate the building's natural lines. The exterior steel bracing appears to be an original building element because it runs parallel to the cornice line.

Exterior buttresses, an integral part of Gothic architecture, are not traditionally part of our architecture. In retrofitting an existing building, it is usually better to use an in-wall or interior bracing system rather than a visible exterior system. When used as an exterior bracing system, care must be taken to avoid damage to existing decorative elements. Even if saved, exterior buttresses can obscure decorative elements.

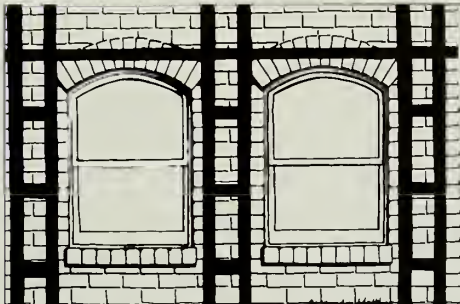
## Not Recommended

- The exterior bracing on this building dominates its appearance. Care should be taken to design exterior bracing to blend with or enhance the building's natural lines.

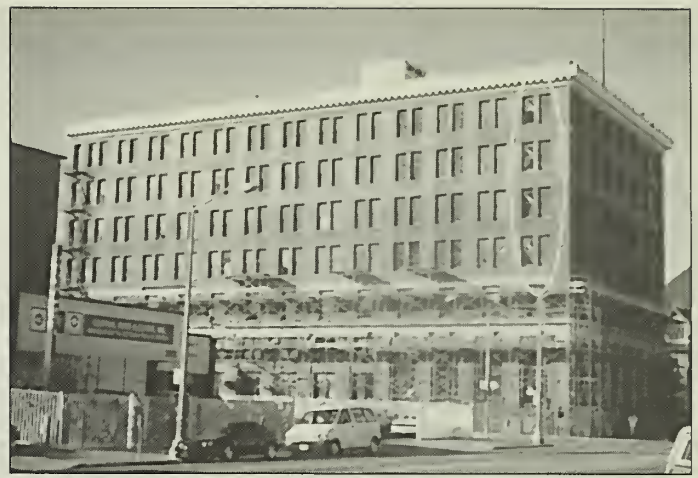
13. Installing diagonal frames, underway in this rehabilitation, are a traditional method of seismic reinforcement. To reduce the impact of the X, K, or diagonal braces, they should be on the inside of the perimeter wall, designed to cross behind solid walls as much as possible, and painted a receding color where visible. Photo: David Look.

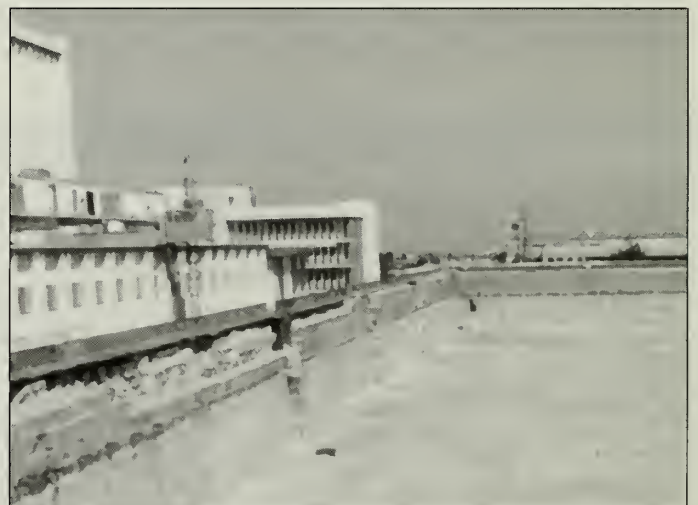
15. The use of fiber composite materials can enhance the shear capacity of existing structural components - beams, columns, and surface elements, such as walls and floors. In this roofing application, the existing roof diaphragm is being strengthened and there is additional benefit to the shear reinforcement of the parapet wall. Photo: The Crosby Group.

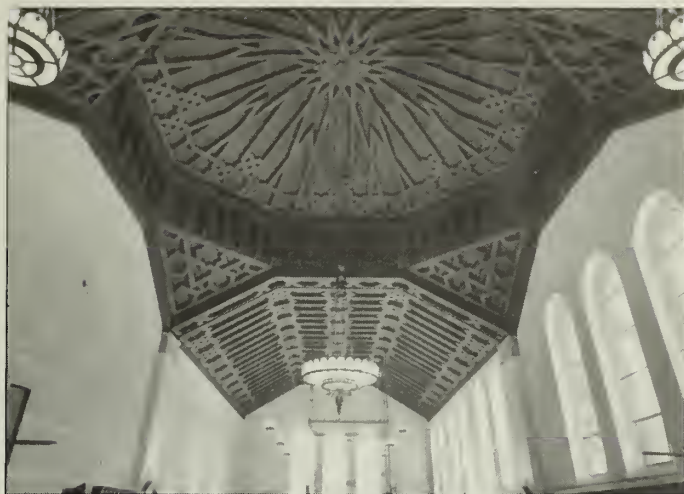
16. During the extensive rehabilitation of this historic building, new concrete, behind the new plaster finishes, strengthened the exterior brick walls and additional roof reinforcement was hidden behind the repaired/reconstructed coffered ceiling. Photo: © Jonathan Ferrar, courtesy UCLA Capital Programs.

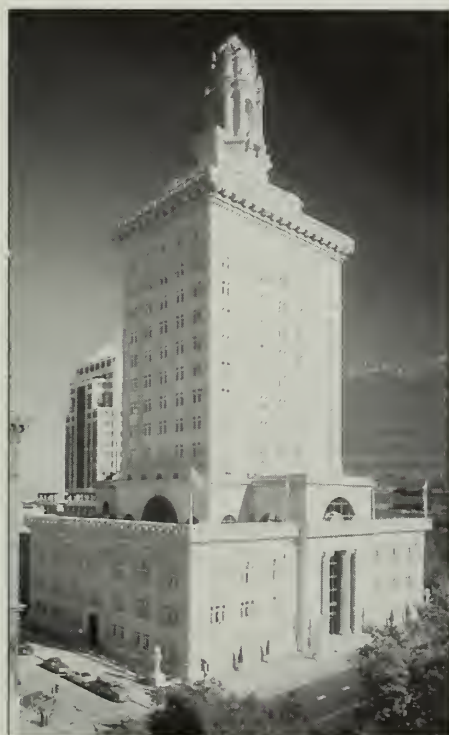
18. Oakland City Hall, California, completed in 1914, was restored to its original appearance and the computer model illustrates the comprehensive methods used to fully reinforce the building for the future. Photo: © Vittoria Visuals; Computer Model: © Douglas Symes, San Francisco. VBN, Architects and Carey & Co, Inc. Architecture.

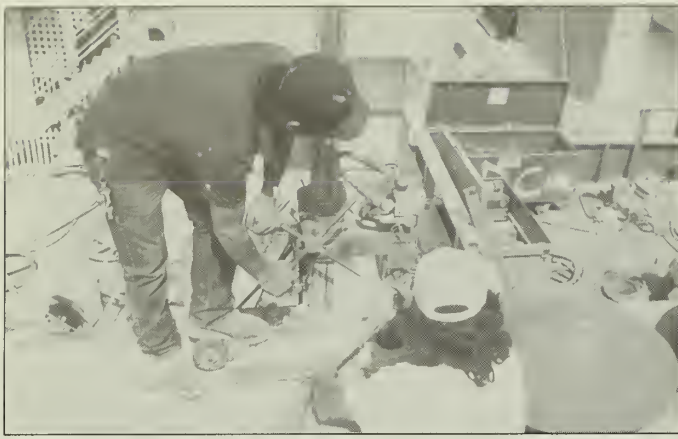
19. A system of core drilling, shown here, removes internal cored sections of unreinforced masonry from roof to foundations and fills them with grout and reinforcing rods. This may be an option for some unreinforced masonry buildings with significant interiors and exteriors, although it is a less reversible treatment than traditional diagonal frames or shear walls. Photo: David Look.

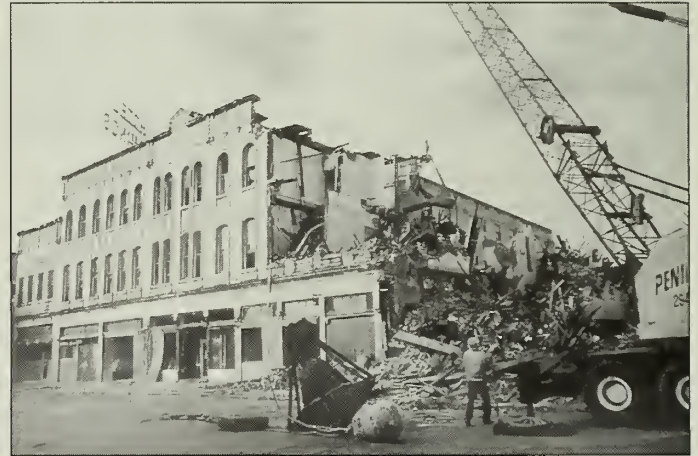
21. Without a plan in place before an earthquake, buildings that could be repaired are often torn down. The loss of significant numbers of buildings within historic districts can further erode the financial and cultural assets of an area. Photo: David Look.

citizens of their relative safety. Heavily damaged areas are often secured off-limits and many red tagged, but repairable, buildings have been torn down unnecessarily because owners were unable to evaluate and present a stabilization plan in time (see illus. 21). Owners or members of the preservation community may engage their own engineers with specialized knowledge to challenge a demolition order. Because seismic retrofit is complex and many jurisdictions are involved, the coordination between various regulatory bodies needs to be accomplished *before* an earthquake.

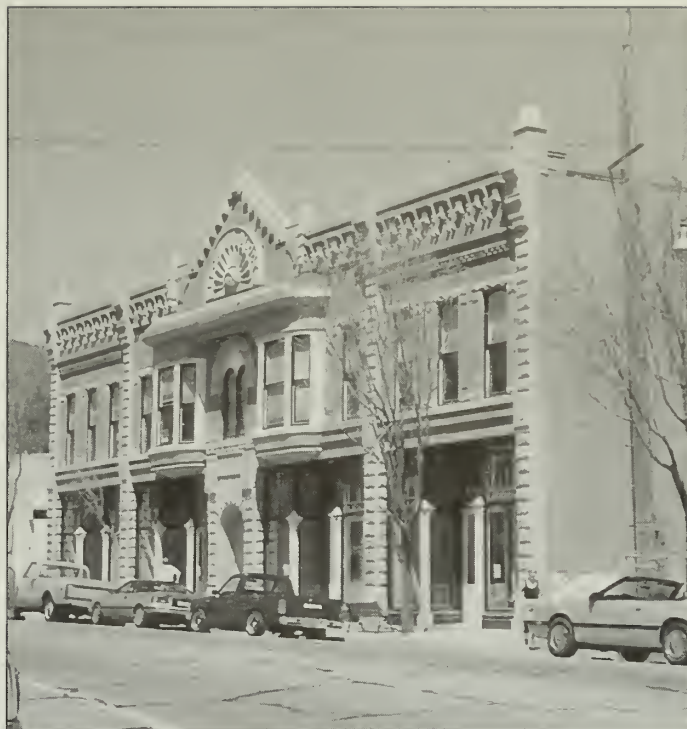
22. When undertaking a substantial rehabilitation to include seismic reinforcement, it is also an opportune time to restore lost or damaged features. The owner of this commercial building, using the Historic Rehabilitation Tax Credits, restored the original bay and parapet gable, and stone detailing that had been removed in an earlier insensitive remodeling. Photo: David Look.

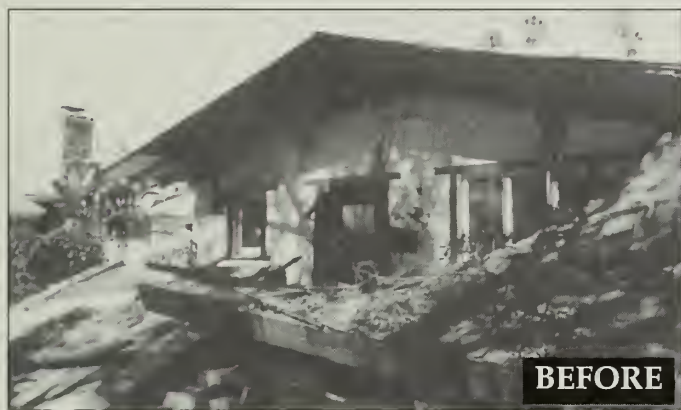
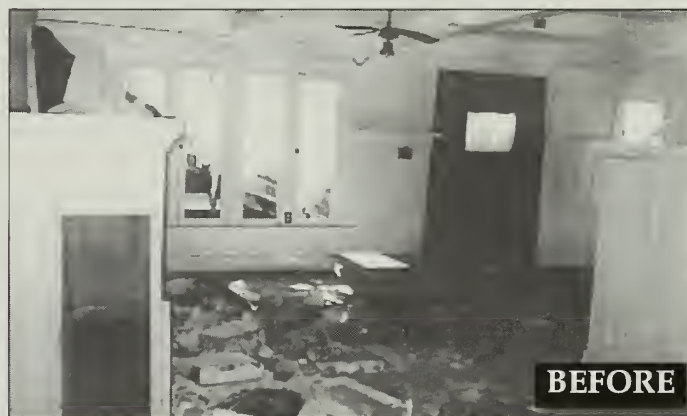
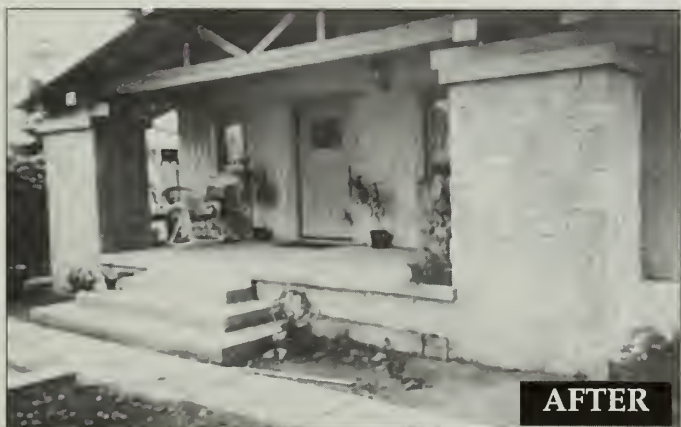
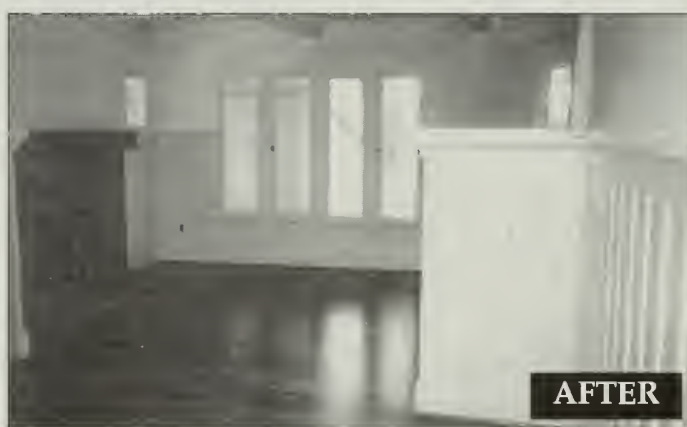
23. Both exteriors and interiors can be severely damaged in an earthquake. This Craftsman Style bungalow was successfully restored and seismically upgraded after the Northridge earthquake in California. Photographs: Historic Preservation Partners in Earthquake Response.

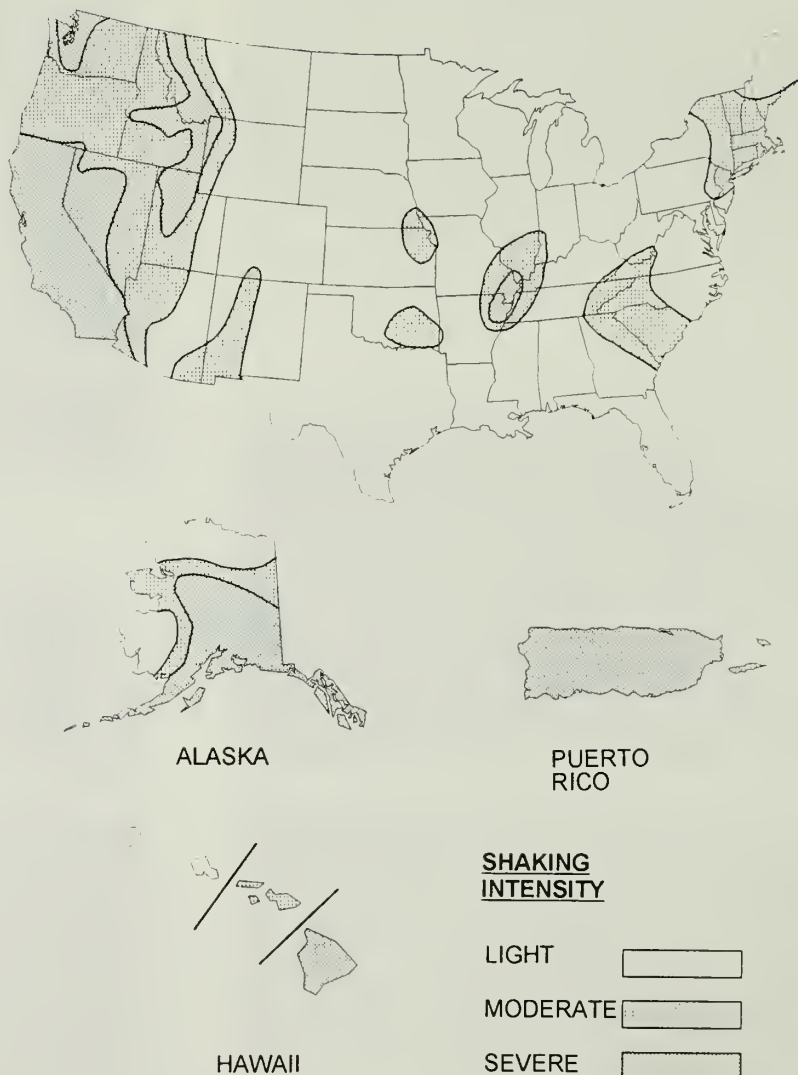
24. Seismic Map. The shading indicate areas in the United States and Puerto Rico that are affected by the probability of varying shaking intensities. The risk of severe shaking is not limited to the west coast. Map: adapted from Federal Emergency Management Agency, FEMA 74 Guide.

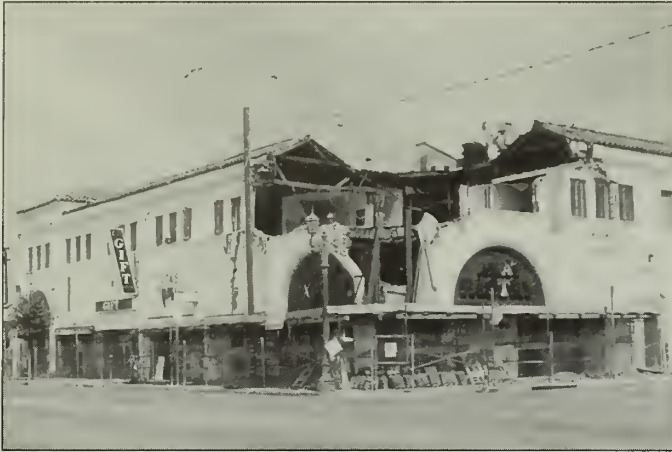
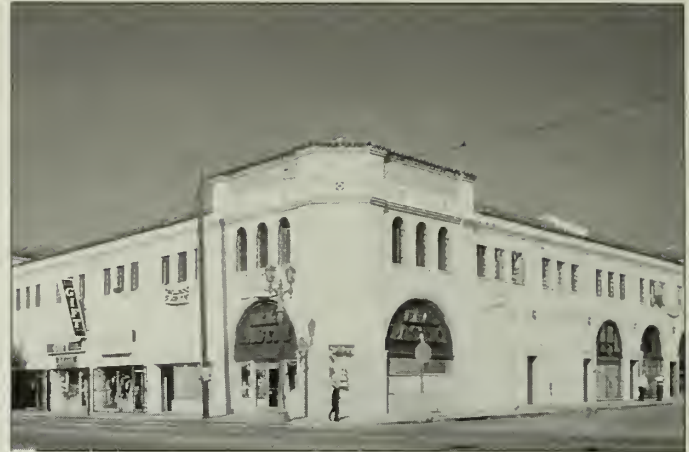
25. While it is best to seismically retrofit historic buildings before an earthquake strikes, if earthquake damage is to be repaired, it should be done in a manner respecting the historic character of the building. For this ca. 1925 Mediterranean Revival style building damaged in the Northridge Earthquake in California, financial and planning assistance from the Historic Preservation Partners for Earthquake Response made possible a sensitive rehabilitation. New structural steel and restoration of the historic stucco and decorative tile work and a repaired tile roof reinstated this earthquake damaged building as a major element of the historic district. Photo: Courtesy Historic Preservation Partners for Earthquake Response, M2A Architects.
